Special Report, 77-39

6
TEMPORARY PROTECTION OF
WINTERTIME BUILDING CONSTRUCTION

Fairbanks, Alaska, 1976-77.

CORPS OF ENGINEERS, U.S. ARMY
COLD REGIONS RESEARCH AND ENGINEERING LABORATORY
HANOVER, NEW HAMPSHIRE

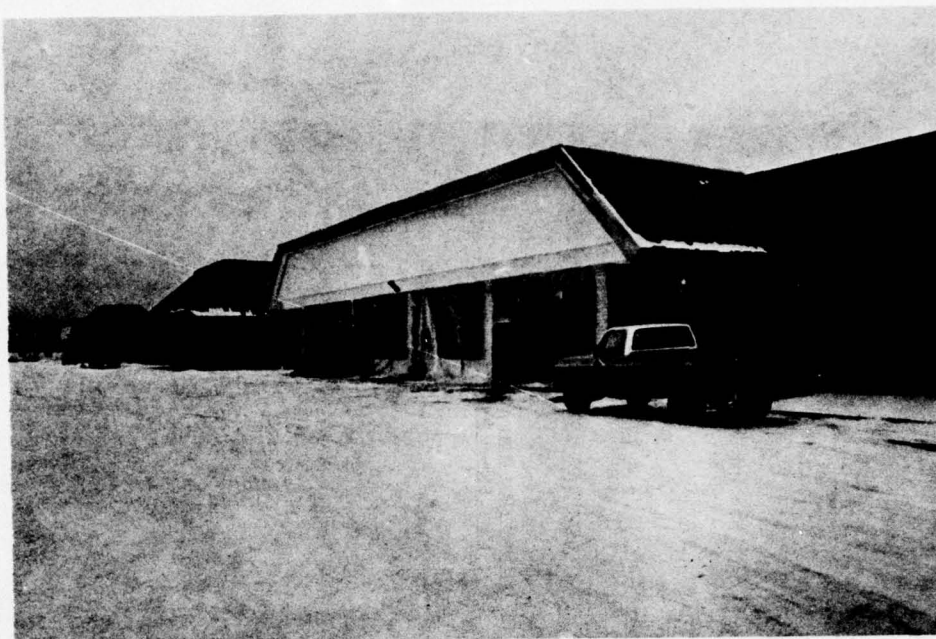
2. General View of Bentley Mall project showing permanent walls and polyethylene sheltered entrance ways. November 28, 1976. +32°F.

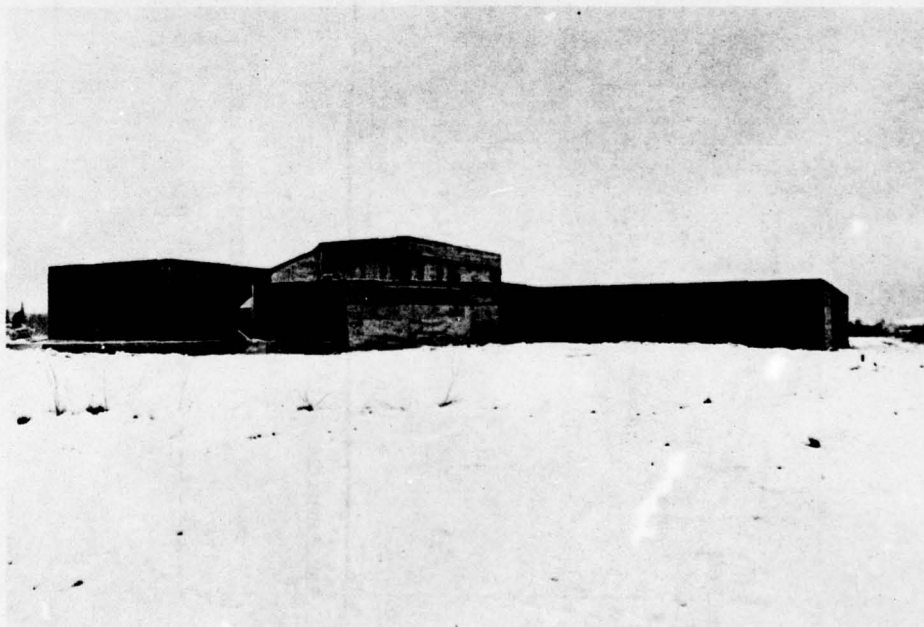
3. General View of Borough Library project. November 28, 1976. +32°F.

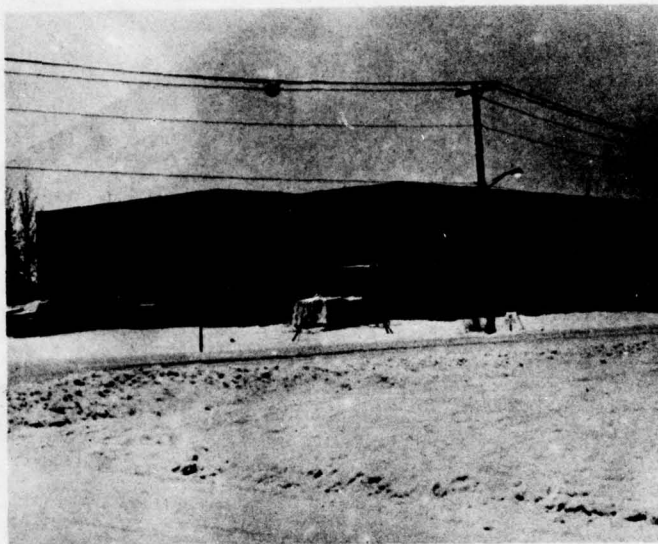
4. General View of Fairbanks Medical and Dental Arts Clinic. November 25, 1976. +14°F.

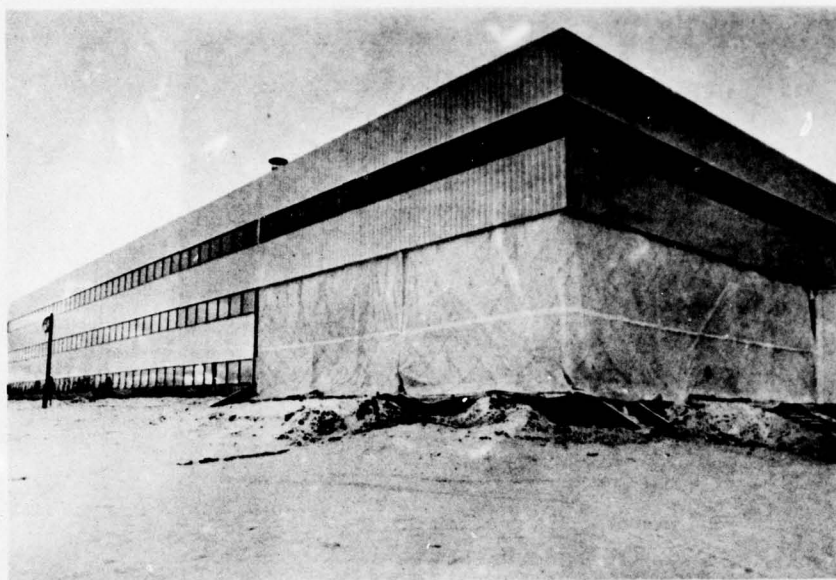
6. General View of Northeast corner of Federal Building. November 28, 1976. 32°F.

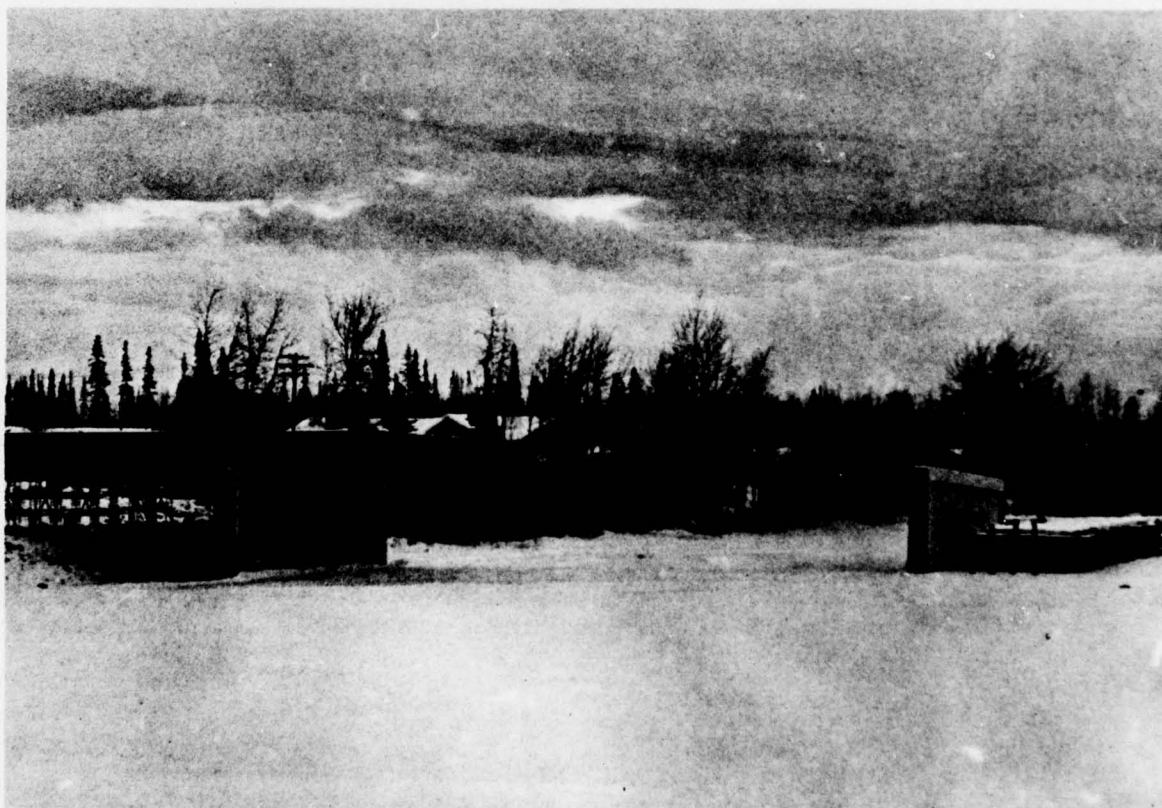
7. Steese Highway Bridge over Chena River, activities suspended over winter. November 28, 1976. 32°F.

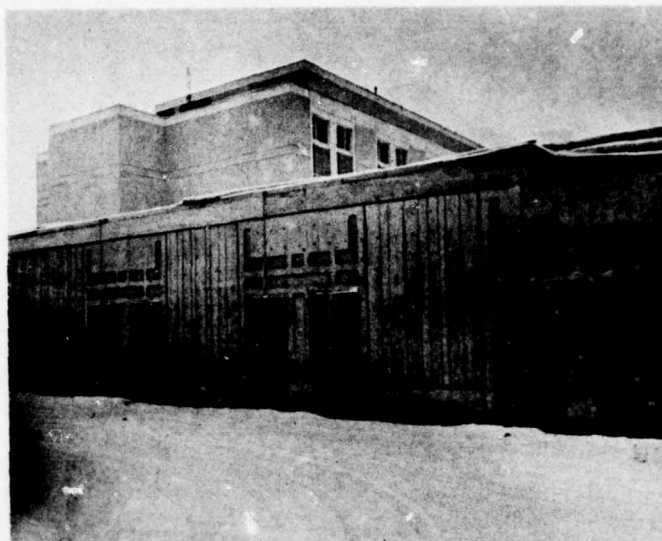
8. Fairbanks Memorial Hospital project lying inactive during winter period. November 25, 1976. +14°F.

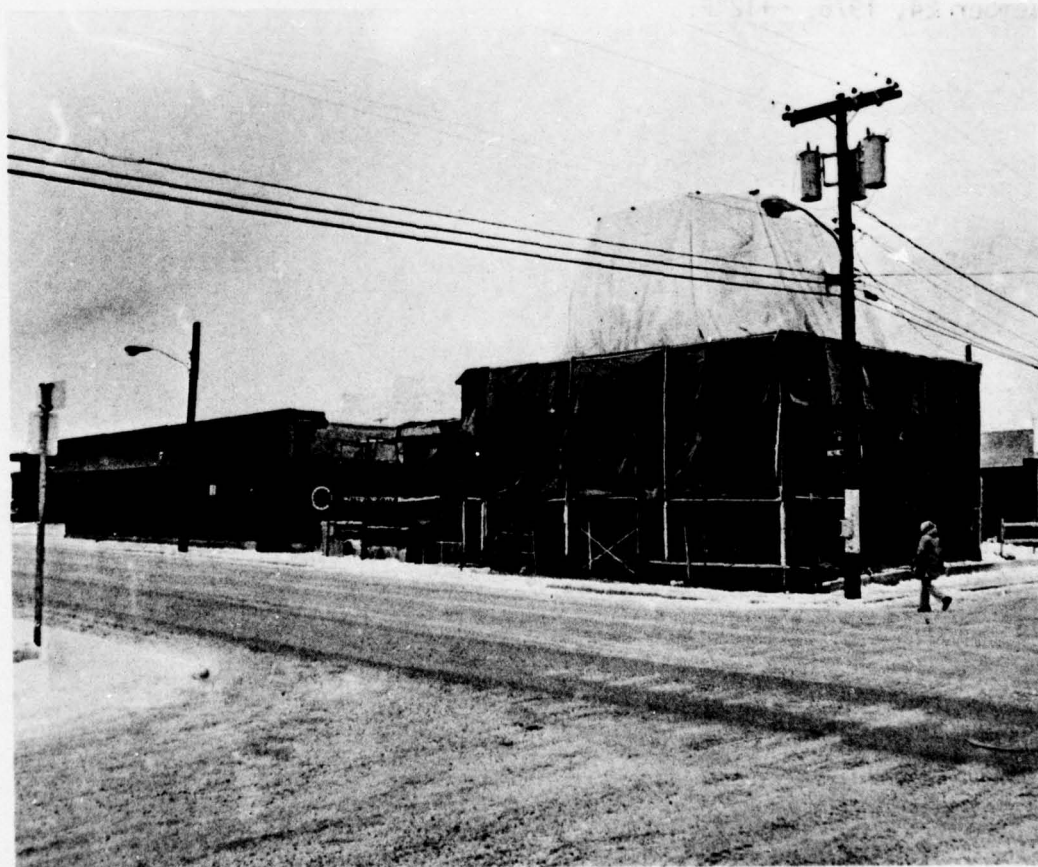
9. General view of addition to Interior City Branch, First National Bank of Anchorage, November 28, 1976, +32°F.

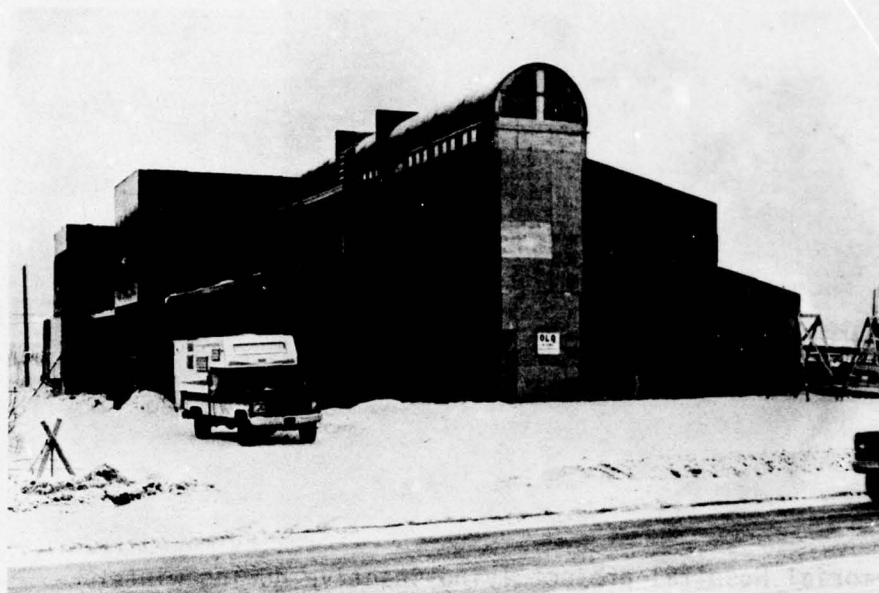
10. General view of Plywood Supply project, looking generally north.
November 24, 1976. +12°F.

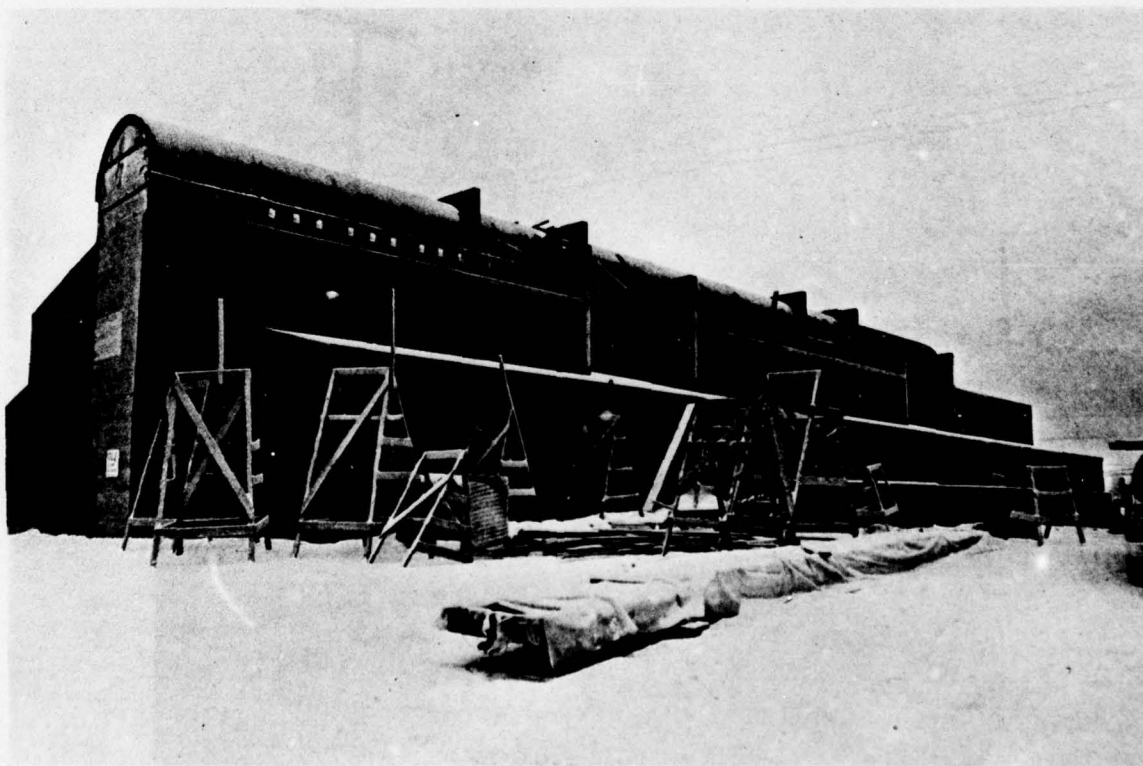
11. General view of Plywood Supply project, looking generally west.
November 24, 1976. +12°F.

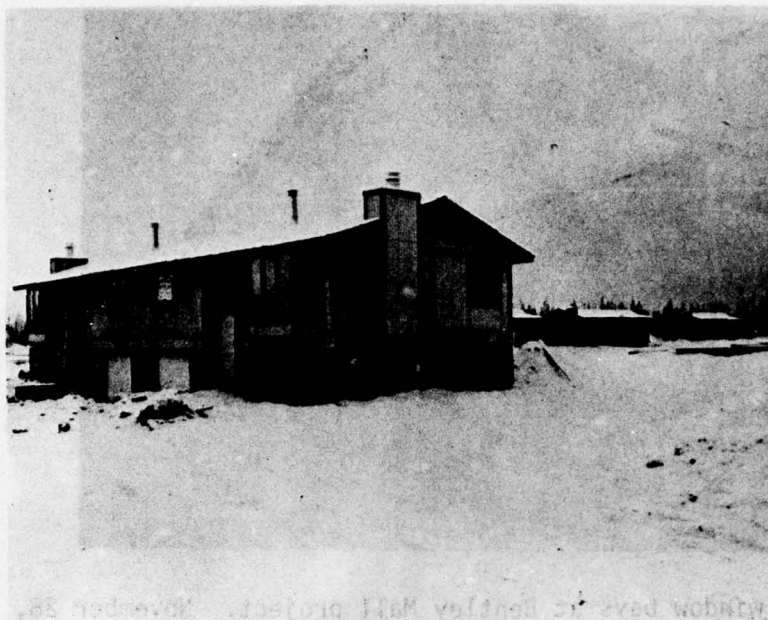
12. General view of one unit in South Westgate Modular Housing project. with work continuing inside. November 25, 1976. +14°F.

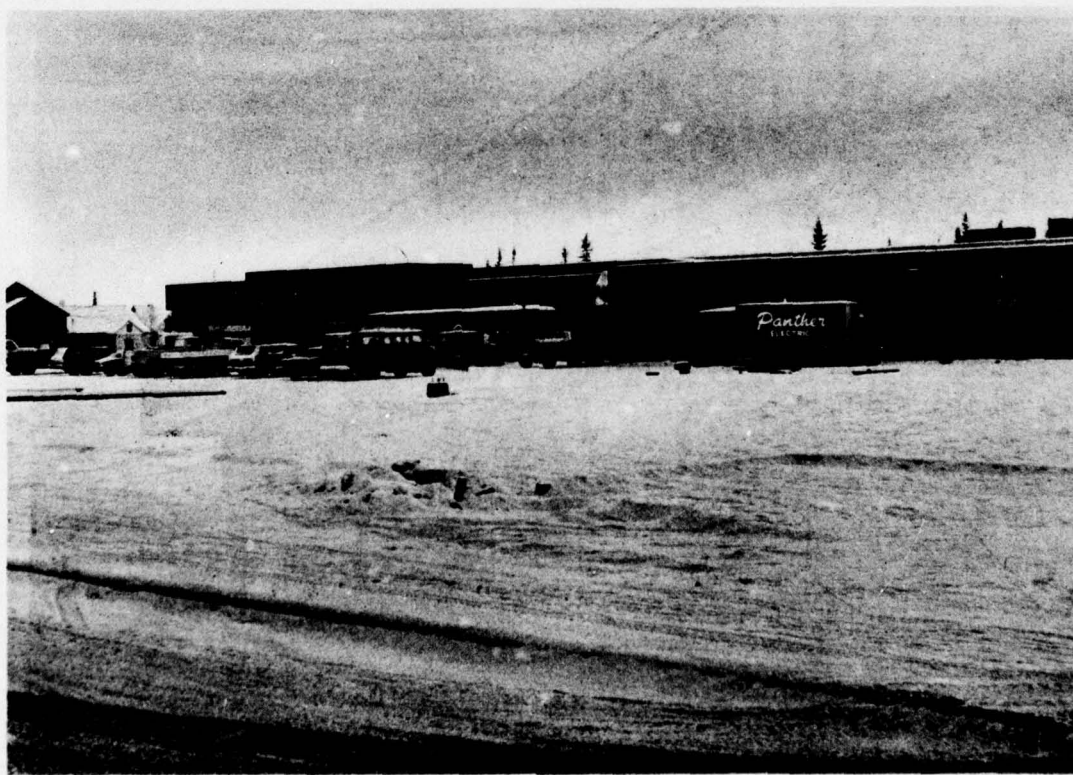
13. General view of University Mall Shopping Center project looking generally south. January 6, 1977. +4°F.

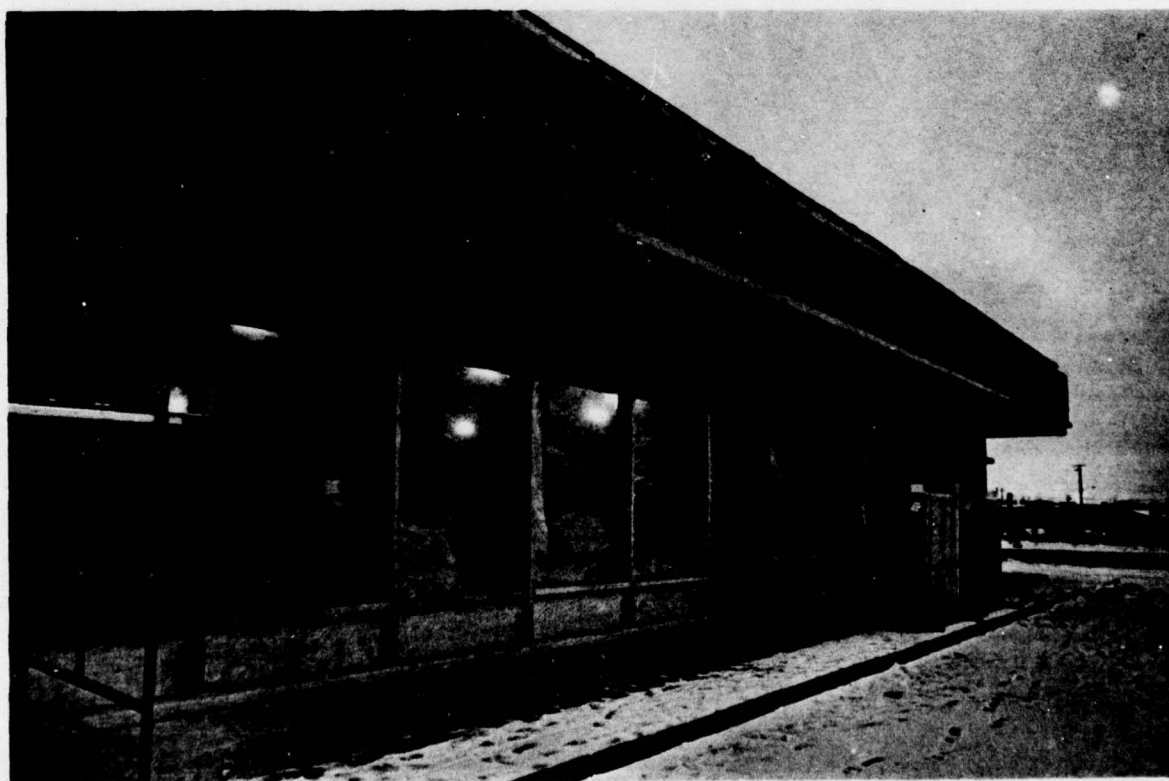
15. Temporary enclosures were window openings, Bentley Mall project. November 28, 1976. +32°F.

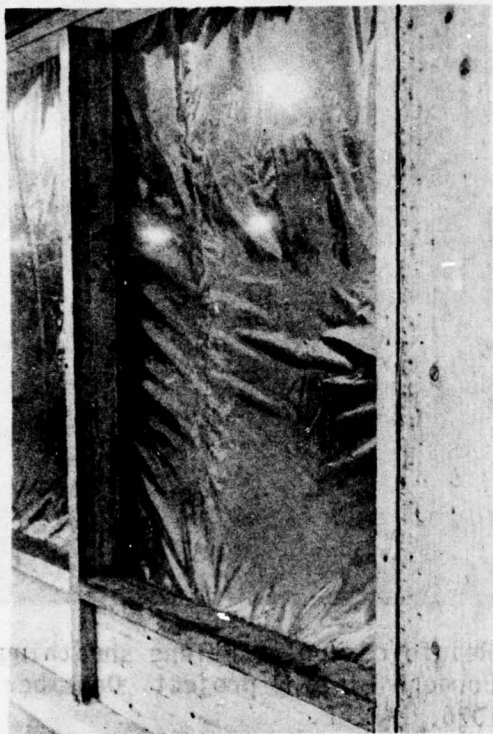
16. Close-up of temporary window coverings, Bentley Mall project. November 28, 1976. +32°F.

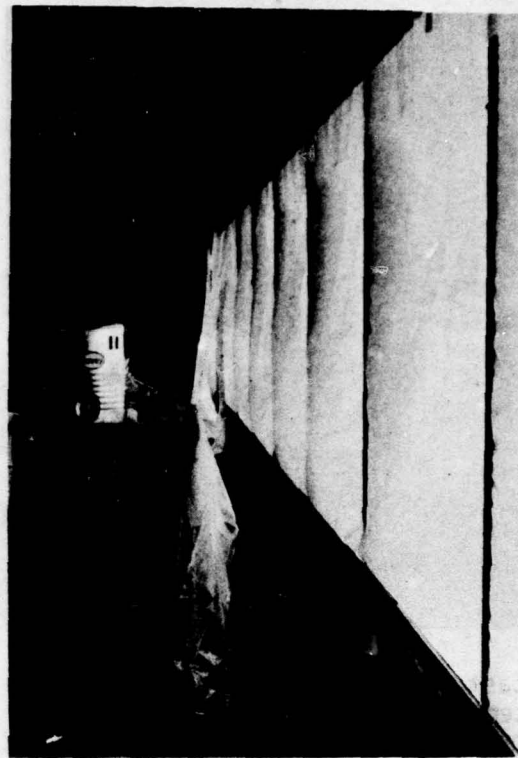
17. Temporary window enclosures at Bentley Mall project, inside view. January 7, 1977. +31°F.

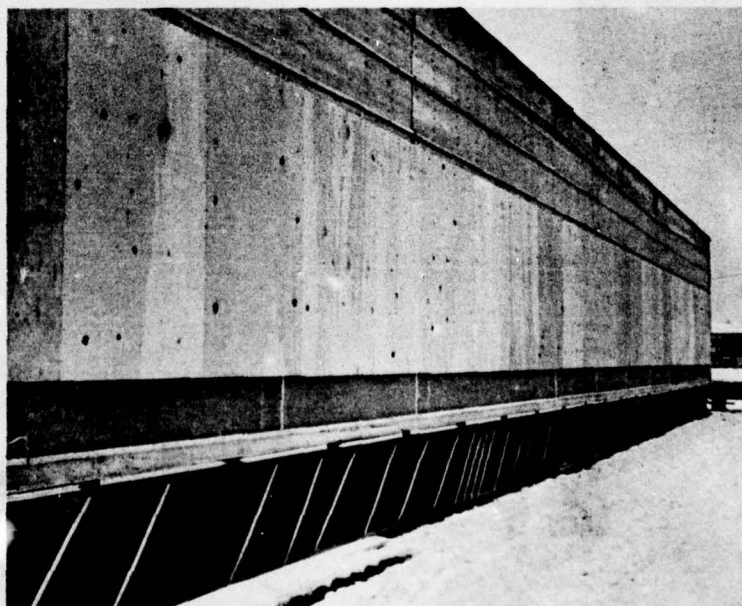
18. North wall, Borough Library project, plywood sheathing protecting window placement activity. November 28, 1976. +32°F.

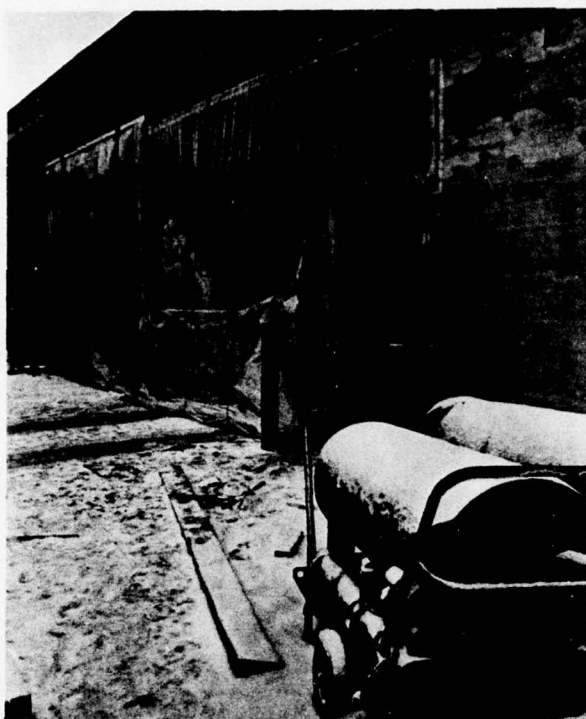
19. East side, Borough Library project, temporary garage door sheltering equipment. November 28, 1976. +32°F.

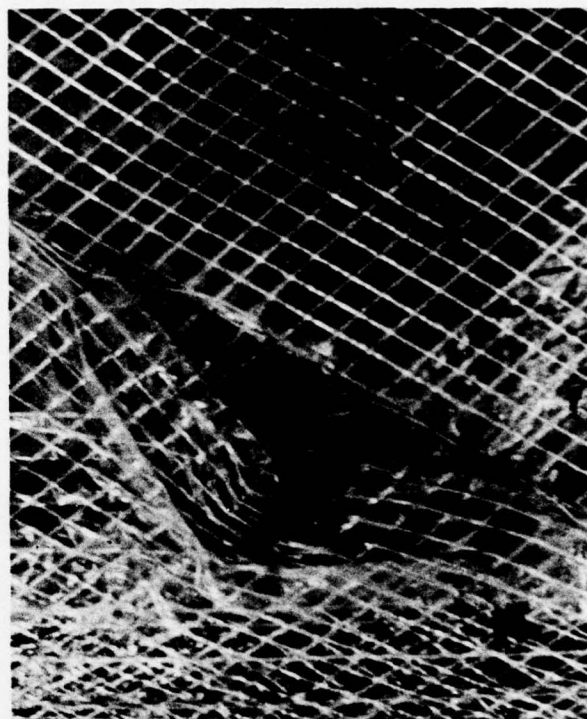
20. Reinforced polyethylene sheathing at Borough Library project. December 30, 1976. -12°F.

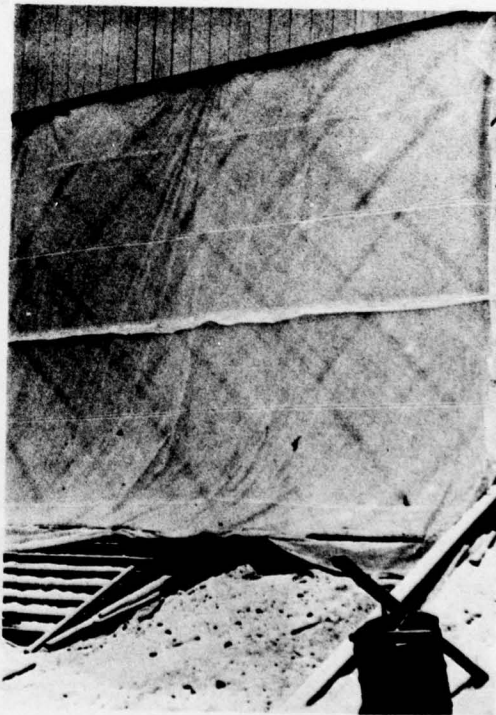
22. Federal Building project. Polyethylene cover on northeast corner. November 28, 1976. +32°F.

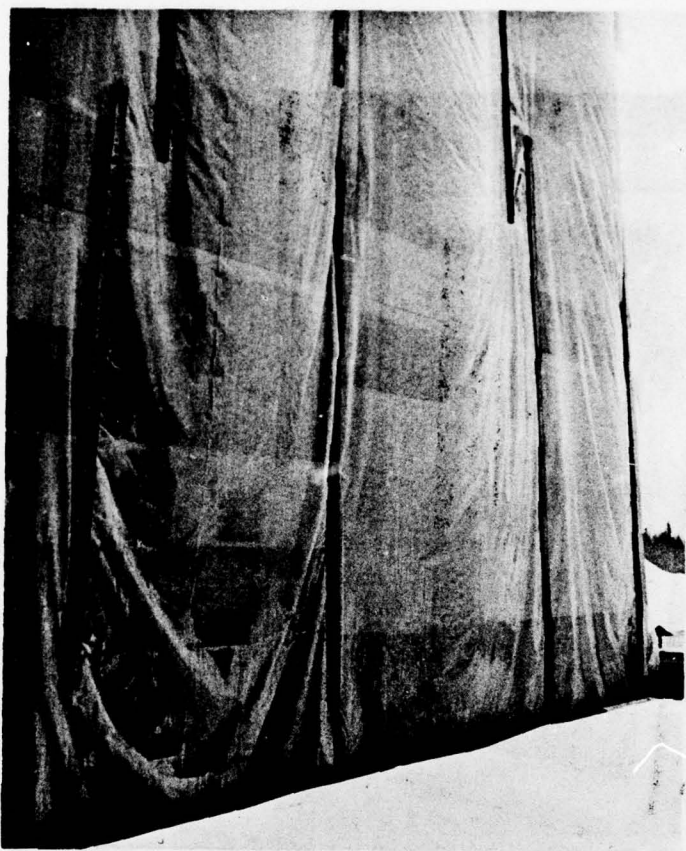
23. Polyethylene cover protecting parking area on southwest corner, Federal Building project. November 28, 1976. +32°F.

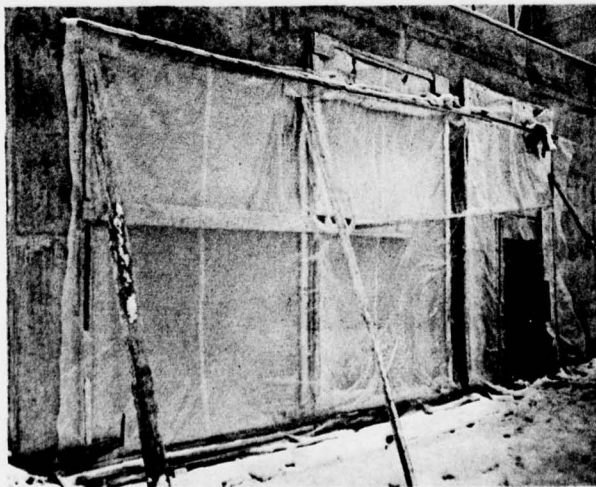
24. Reinforced polyethylene sheathing providing temporary enclosure for garage door at Federal Building project. November 24, 1976. +12°F.

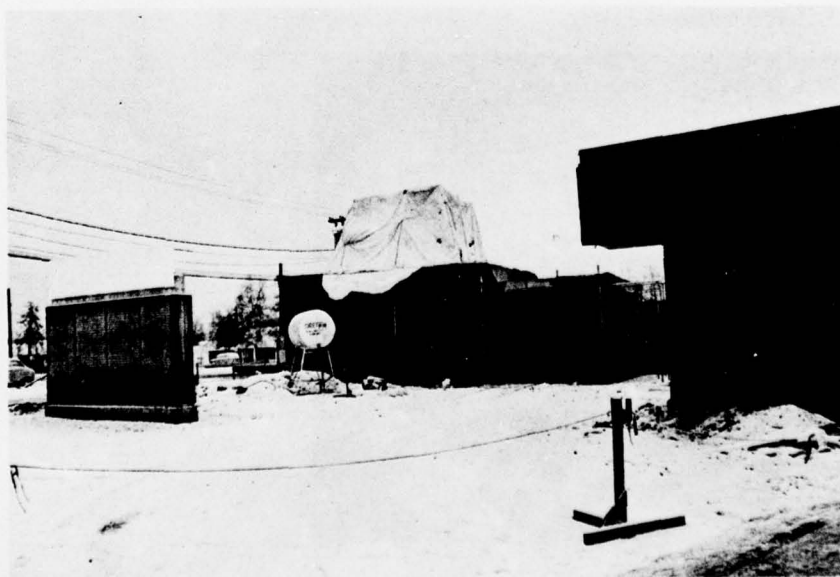
26. South and west walls of Interior City Branch project. November 28, 1976. +32°F.

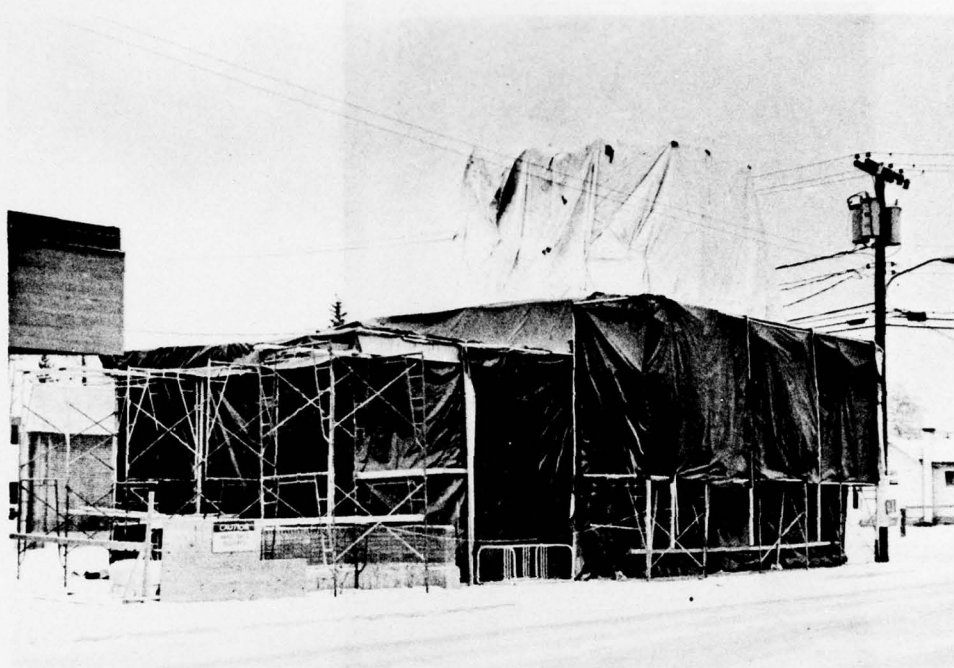
27. South and east walls of Interior City Branch project. November 28, 1976. +32°F.

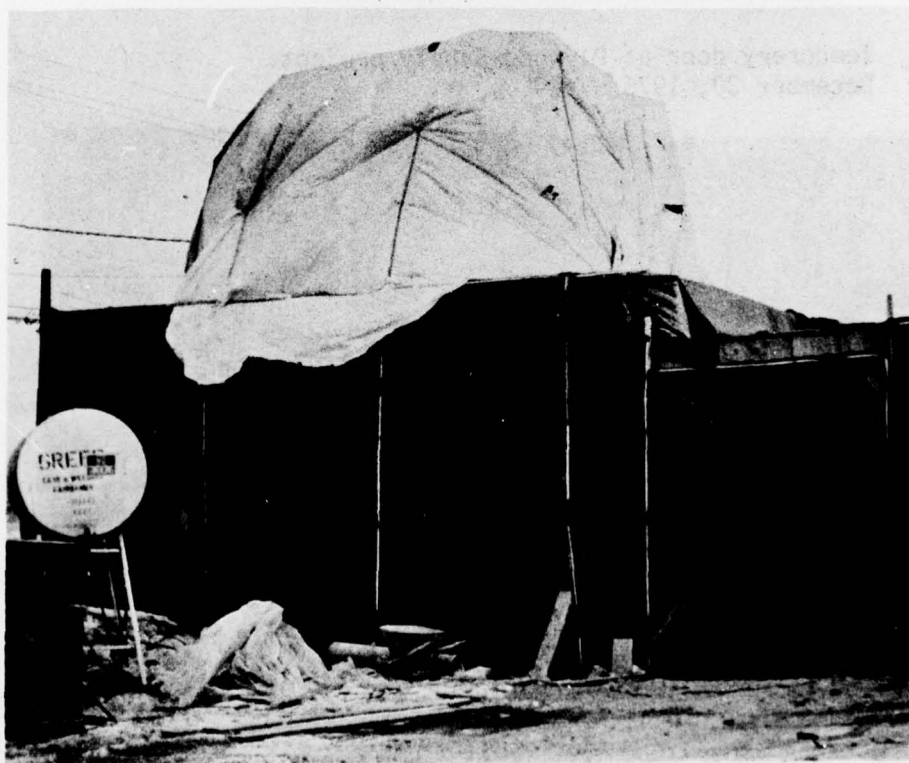
28. Close-up of west wall of Interior City Branch. November 20, 1976. +7°F.

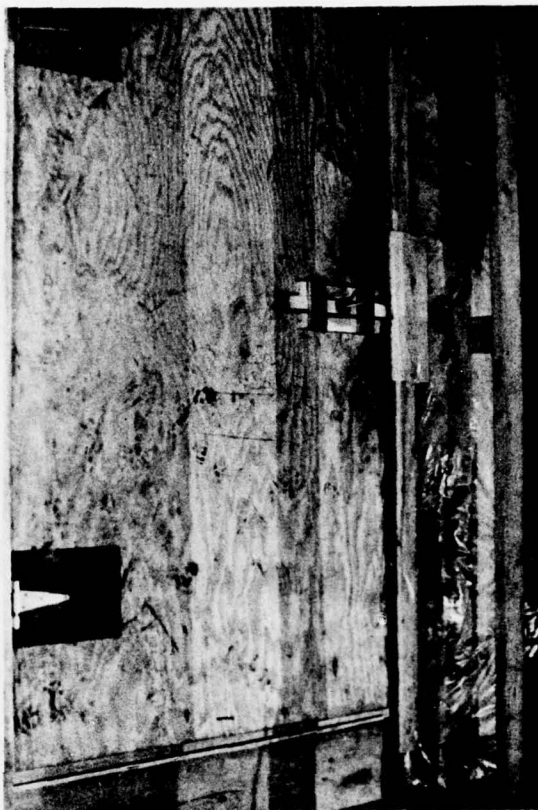
29. Temporary door at Plywood Supply project.
December 30, 1976. -70°F.

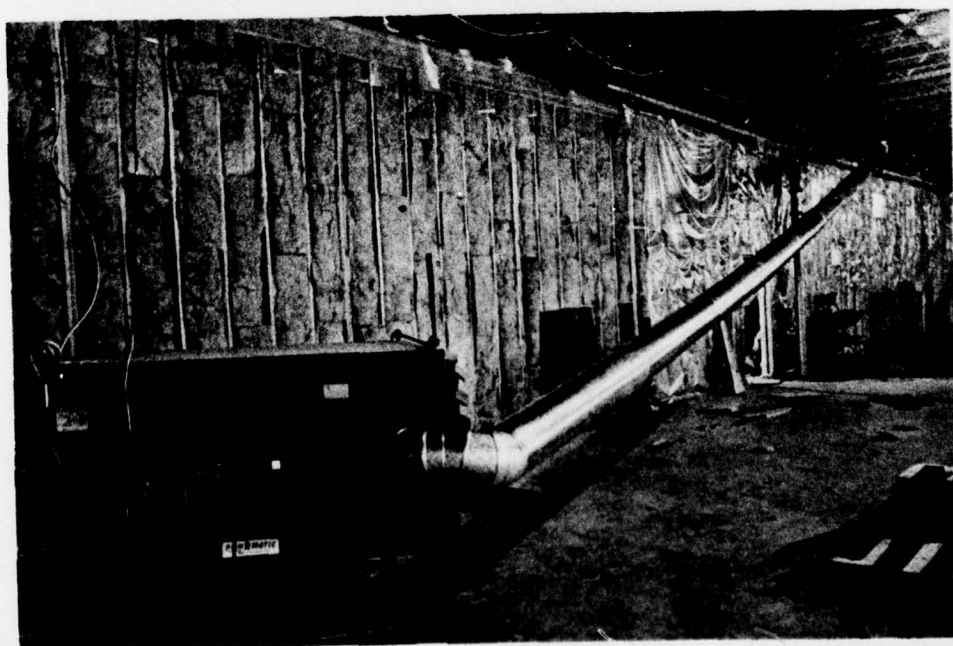
30. "Powrmatic" 450,000 BTU furnace at Bentley Mall project. November 28,
1976. +32°F.

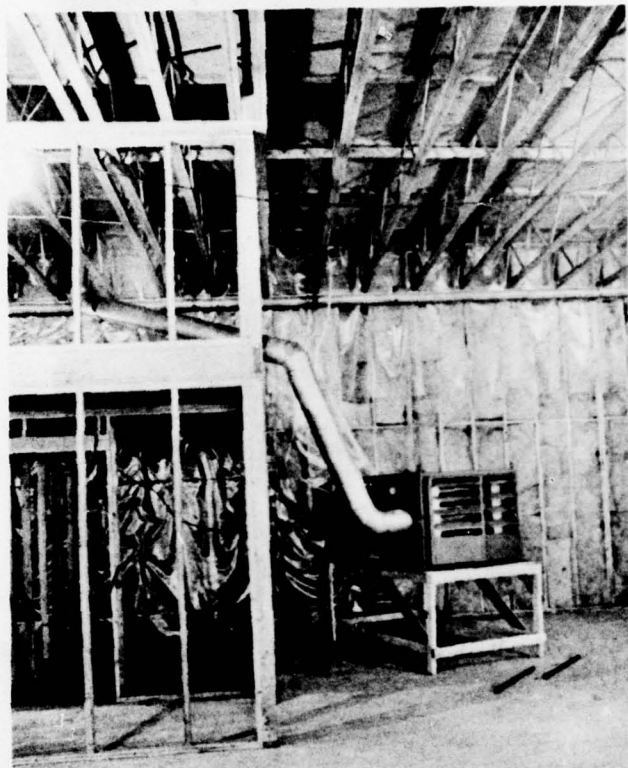
31. Temporary furnace with exterior vent duct, Bentley Mall project. November 28, 1976. +32°F.

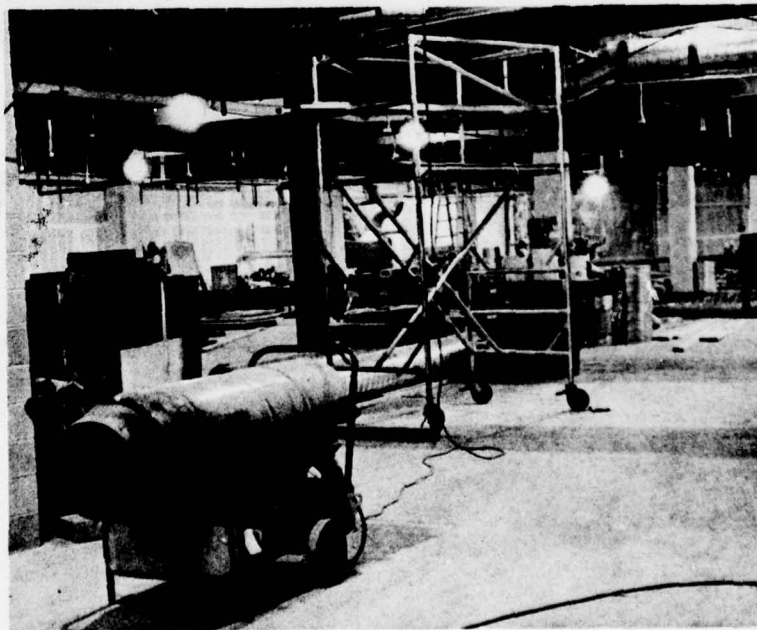
32. "Master" heater, foreground and "Armstrong" furnace, background, at Borough Library project. December 30, 1976. -12°F.

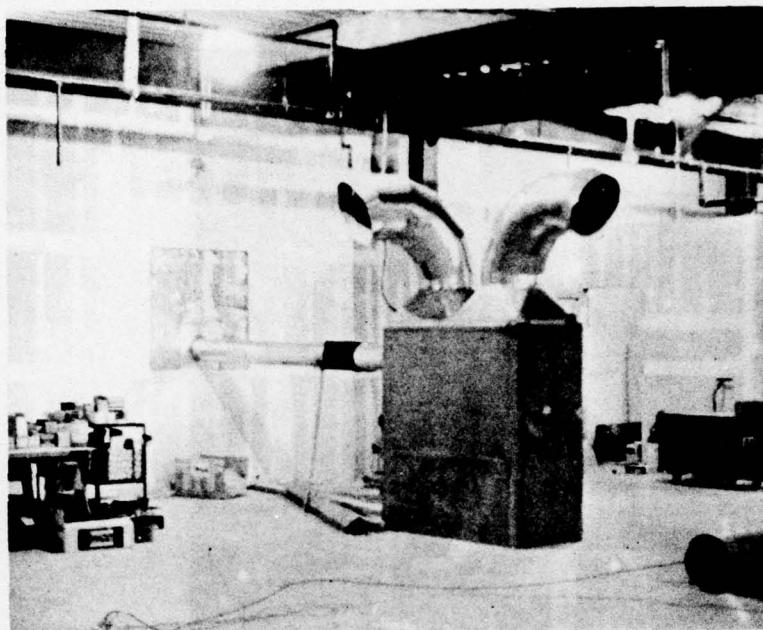
33. "Armstrong" furnace (450,000 BTU per hour) at Borough Library project.
November 30, 1976. -12°F .

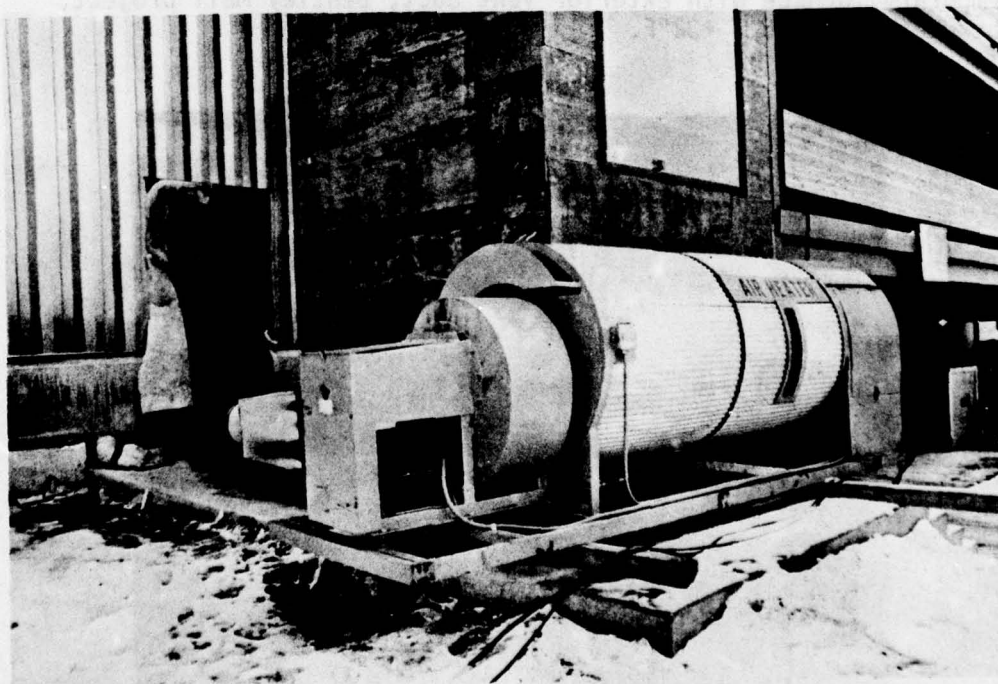
The large volume at the Federal Building project was heated by four large capacity heaters. These units included two "Master" heaters of one million BTU's per hour capacity each and two "Tioga" oil-fired furnaces of two million BTU's per hour capacity each. Figure 34 shows one of the two "Tioga" heaters at the Federal Building, while Figure 35 gives a detail of the ducting that carried heated air from this heater into the building. Figure 36 shows the other "Tioga" heater, which in this case was trailer mounted. It should be noted that both these units were installed outside the building, and heated air was conducted from the heaters into the building.

34. 2 million BTU per hour "Tioga" furnace at Federal Building project.
November 24, 1976. $+12^{\circ}\text{F}$.

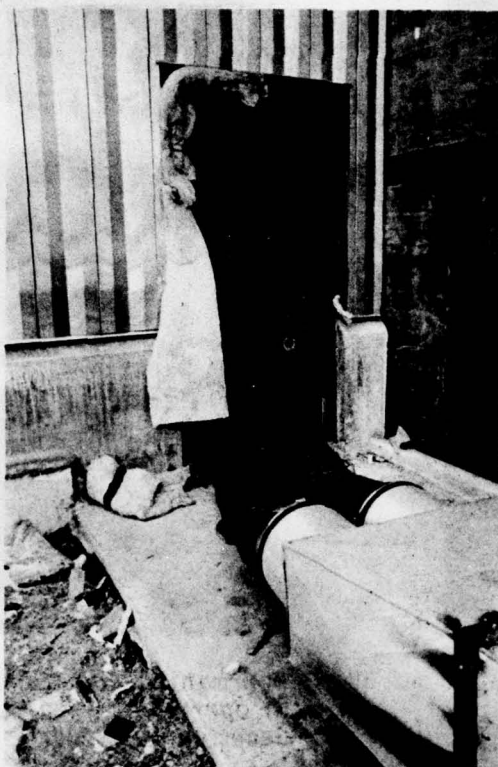
35. Close-up of ducting for Tioga heater,
Federal Building. November 24, 1976.
+120F.

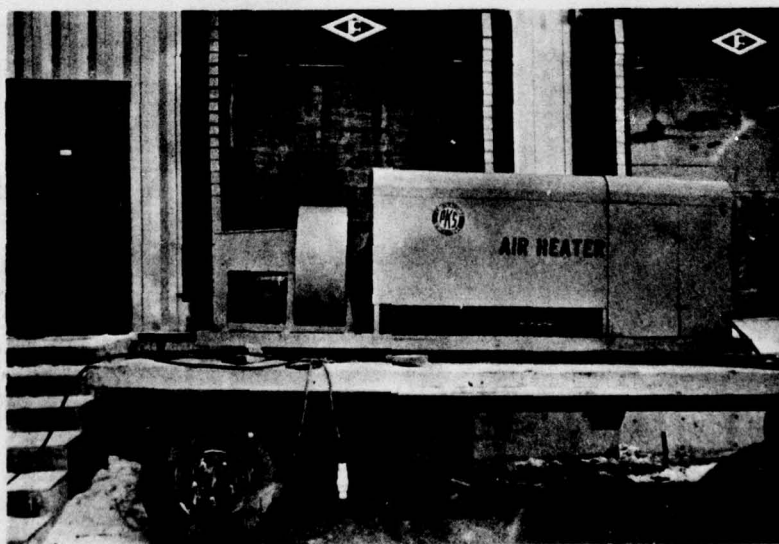
36. Trailer mounted Tioga heater at Federal Building project.
November 24, 1976. +12°F.

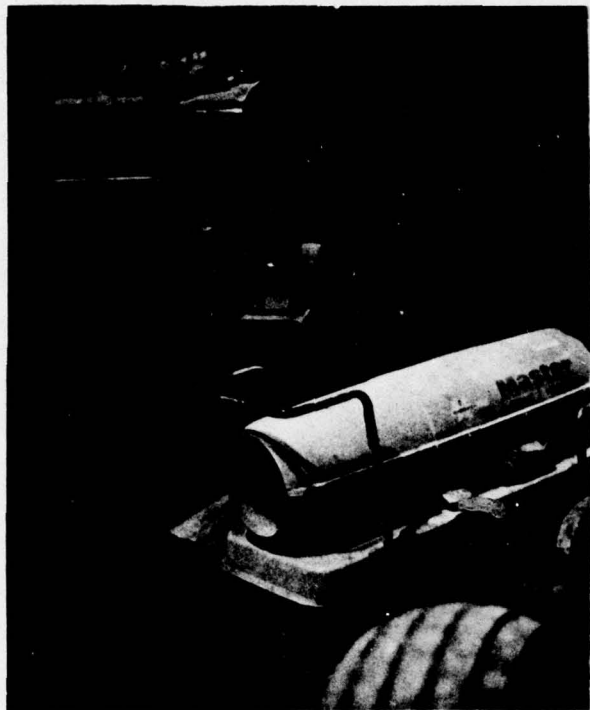
37. Space heater for temporary use at Interior Branch project. November 20, 1976. +7°F.

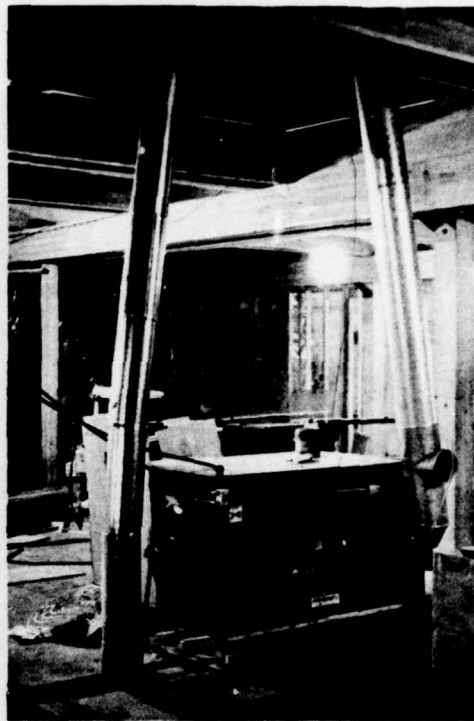
38. "Powrmatic" 450,000 BTU per hour furnace in operation at Plywood Supply project. December 30, 1976. -7°F.

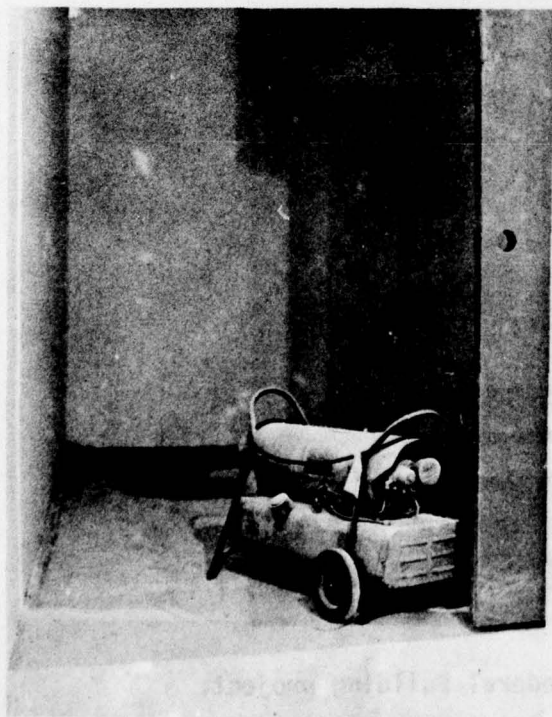
39. "Master" heater drying a damp corner at University Mall project. January 6, 1977. +4°F.

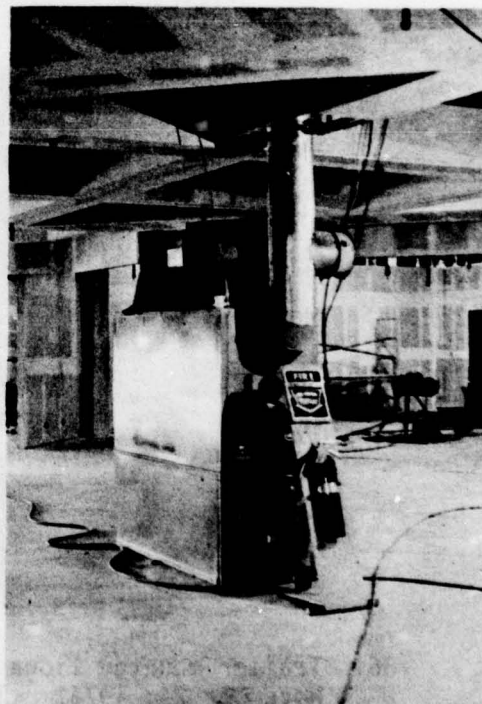
40. "Flexaire" 500,000 BTU per hour furnace in operation at University Mall project. January 19, 1977. -2°F.

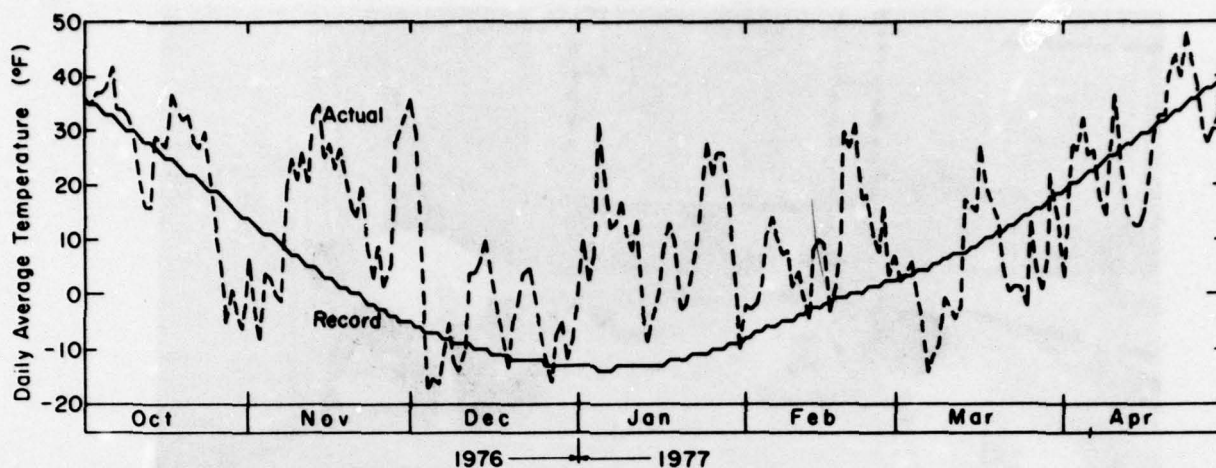
Weather conditions in the Fairbanks, Alaska, area in 1976-77 winter were considerably warmer and drier than normal. Figure 41 contains a graph of daily average temperatures for the winter as recorded at the Fairbanks International Airport. Comparison of the "actual" with "mean" averages indicates that on very few days was the actual temperature less than the mean for the date and that, for many days, the actual temperature was considerably in excess of the mean for the date.

41. Graph of Fairbanks temperatures, winter 1976-77.

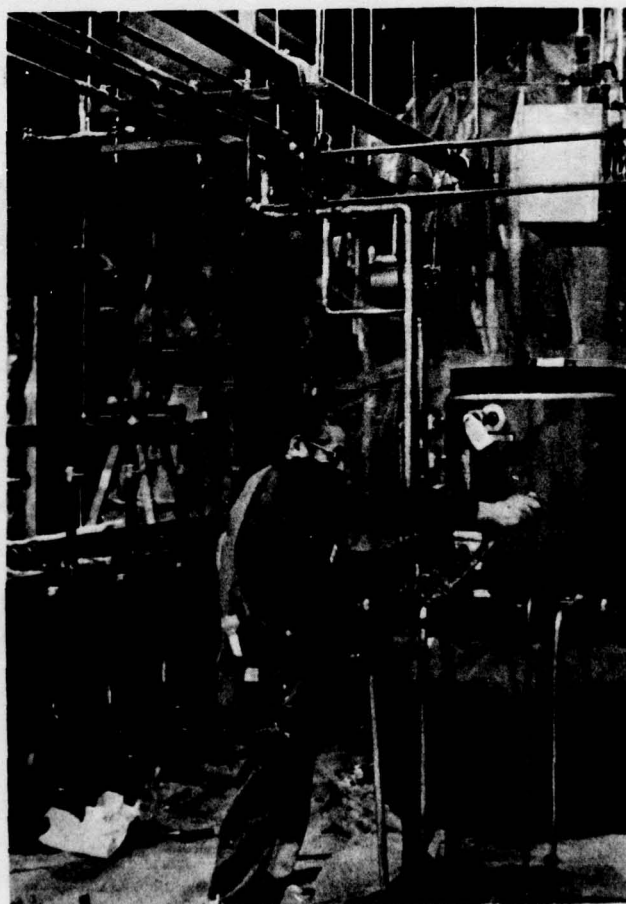
Figures 42 through 46 show a scattering of various construction activities that were conducted inside of buildings under construction while wintertime conditions prevailed. In Figure 42, a pipefitter tightens a connection at the Borough Library project while the outside temperature is -12°F. Figure 43 shows carpenters laying out a reception room at the Fairbanks Medical Clinic project while the outside temperature is +3°F, and Figure 44, taken at the Federal Building project, shows an always-important construction activity --the storage of materials -- while the exterior temperature was +12°F. In Figure 45, an ironworker installs bolts at the Interior City Branch project while the temperature is +14°F. Finally, Figure 46 shows a general view of the interior of the Plywood Supply project, kept warm to temperatures between 50° and 61°F while the outside temperature was -7°F.

42. Workman completing the job in shirtsleeve comfort, Borough Library project. December 30, 1976. -12°F.

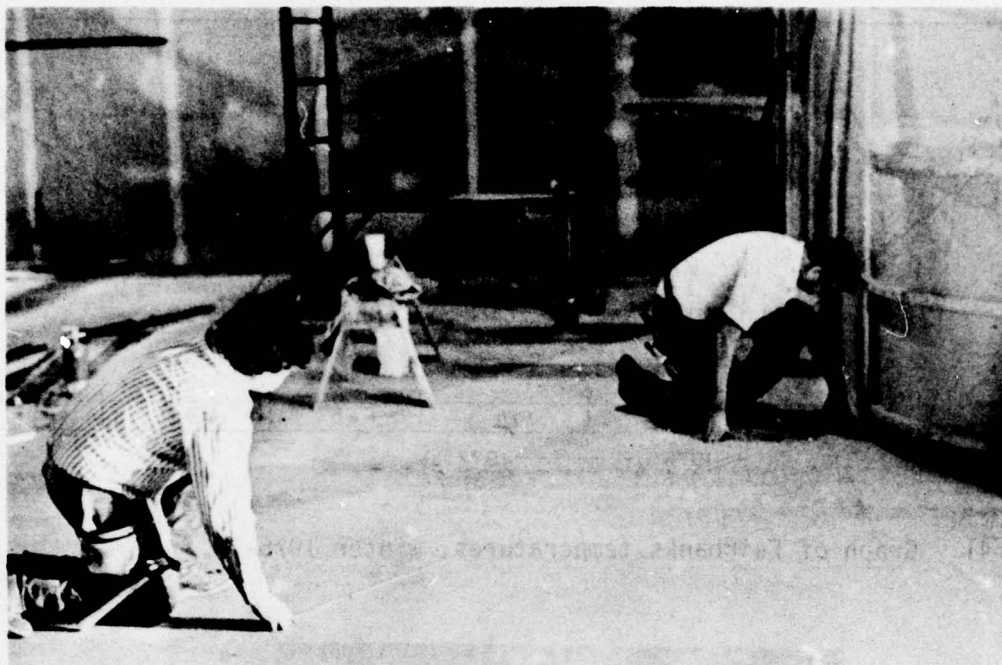
43. Carpenters laying out a reception area, Fairbanks Medical Clinic. January 6, 1976. +3°F.

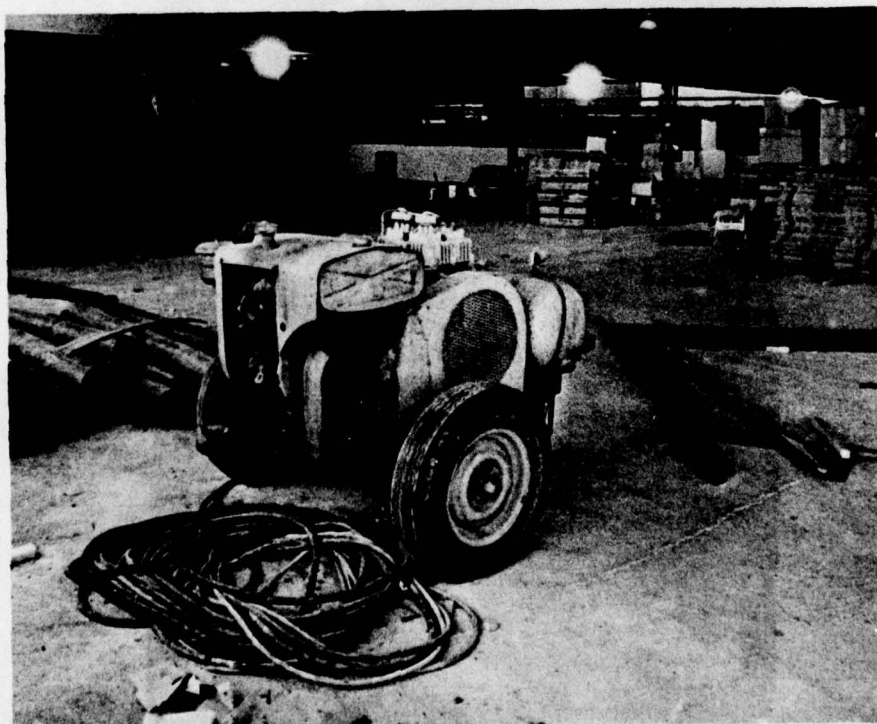
44. Storage of equipment and materials at Federal Building parking garage. November 24, 1976. +12°F.

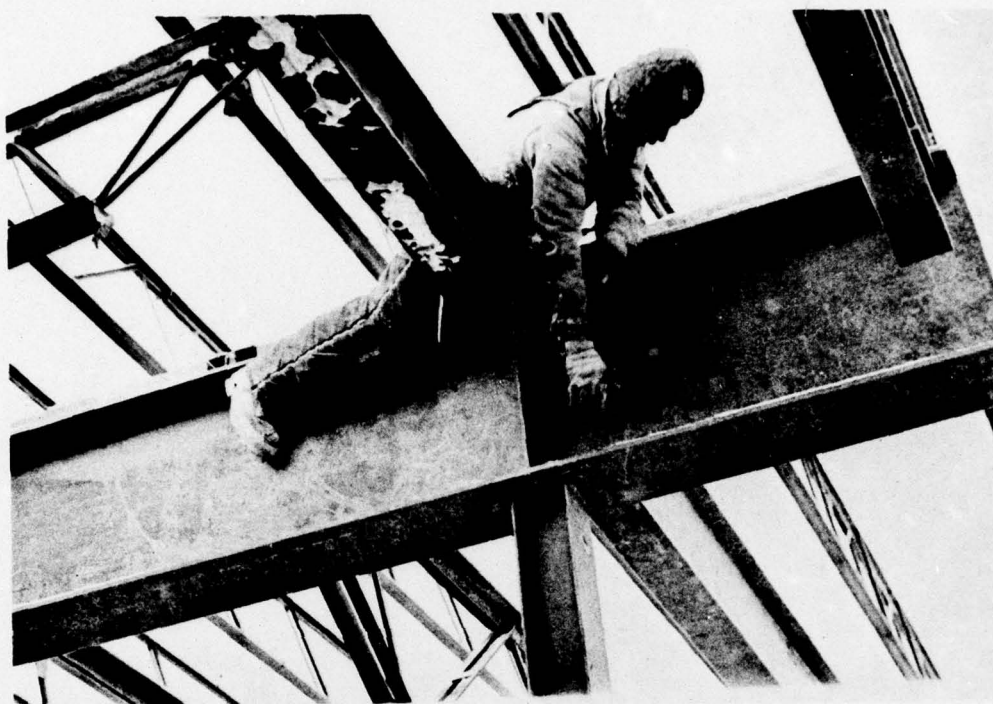
45. Ironworker installing bolts at Interior City Branch project. January 7, 1977. +14°F.
